To: Andy Lind,
Superintendent, White Sulpher Springs Schools
Thomas Vail,
Principal, White Sulpher Springs Schools

Date: 4.8.14

Re: Safety Assessment; Items Needing Immediate Attention.

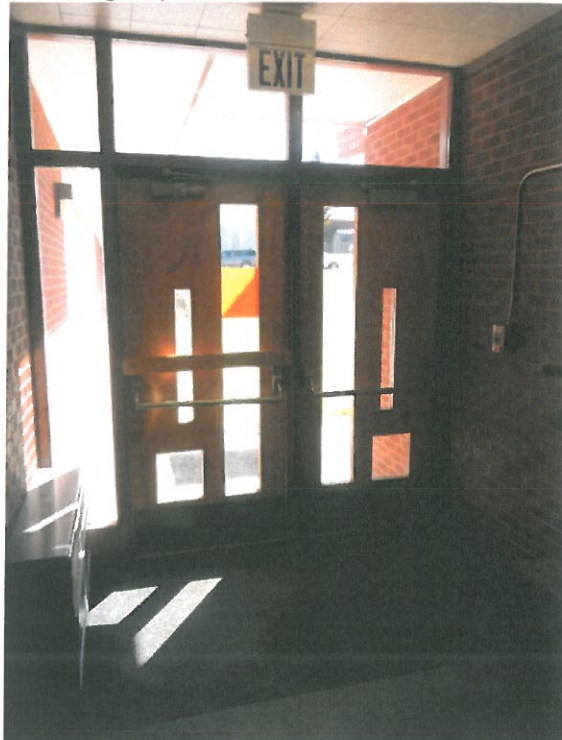
There are several safety concerns which I believe must be addressed immediately. An egress door in the high schools is purposefully barred with a 2x4 and bolts eliminating access to 25% of the exits on that side of the building. This creates a significant hazard for students and staff needing to exit the building in an emergency.

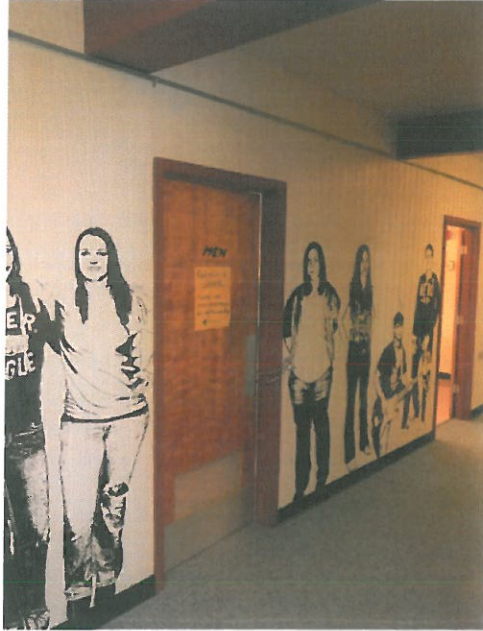
The high school boy's bathroom is barred. Leaking plumbing pipes, leaking sewage into the crawl space below the school prompted the closure. It has been locked off for several months denying the boys 50% of their bathroom space and no efforts are currently being made to repair the piping and return the bathroom to service.

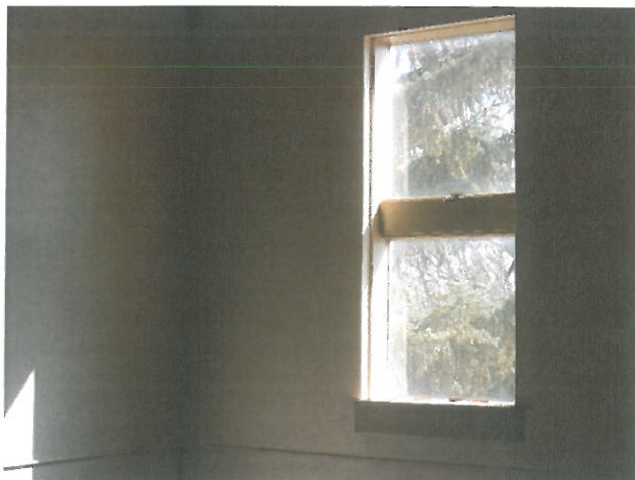
The elementary school has two floors above grade and one below. There is a staircase that connects the first and second floor. The ceiling in this staircase is approximately 20' high. The window at the top of this staircase is broken and cracked and represents a significant hazard of falling glass on any child or staff member on the stair case anytime the wind blows.

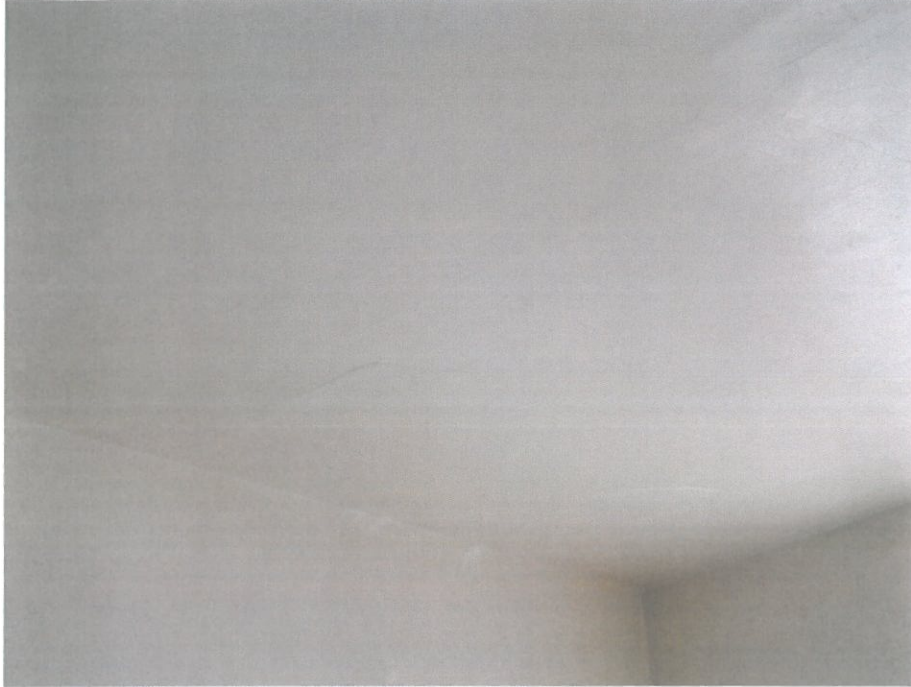
The plaster on the ceiling in this staircase is cracked and represents a significant hazard of falling on any child or staff member using the stair case. My photograph does not show the cracking clearly because of the lighting; I would encourage the reader to inspect this and the other parts of the ceiling throughout the building.

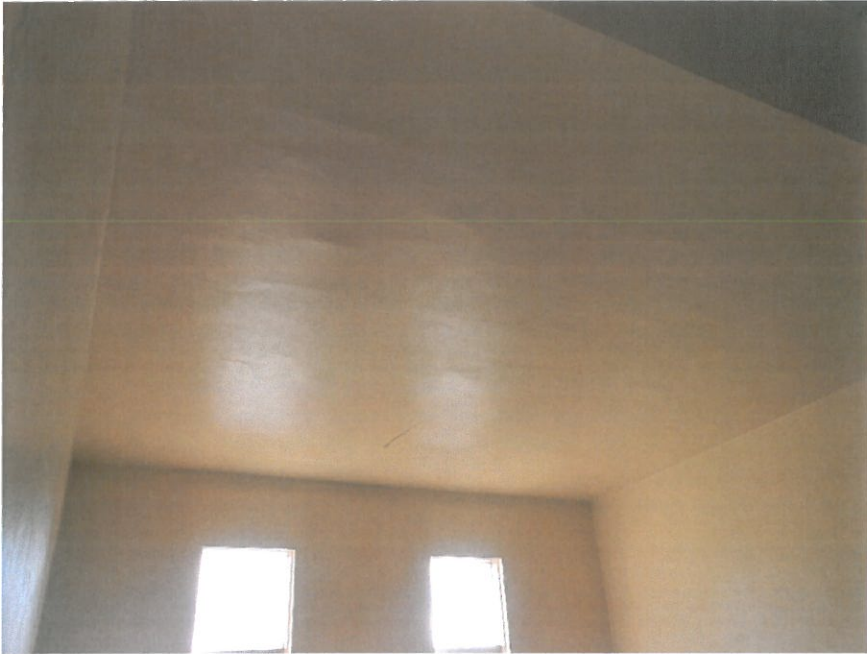
This photograph illustrates another section of the ceiling and its cracking.

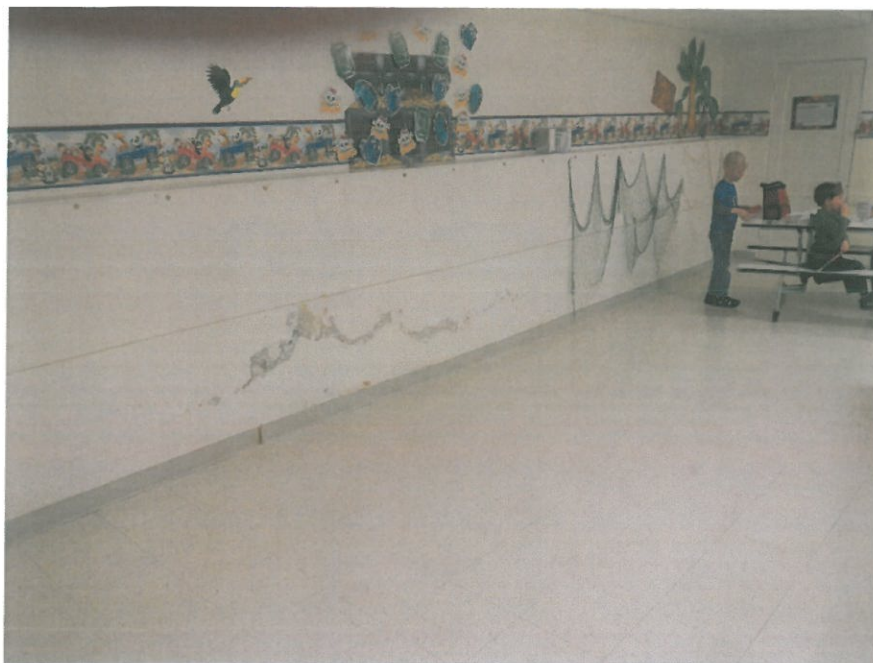
Mold is present in multiple areas of the school because of the failing roof, gutters, windows, sewage and ground water seepage.

This photograph shows the seepage and mold in the elementary school lunchroom; there are other areas which contain mold.

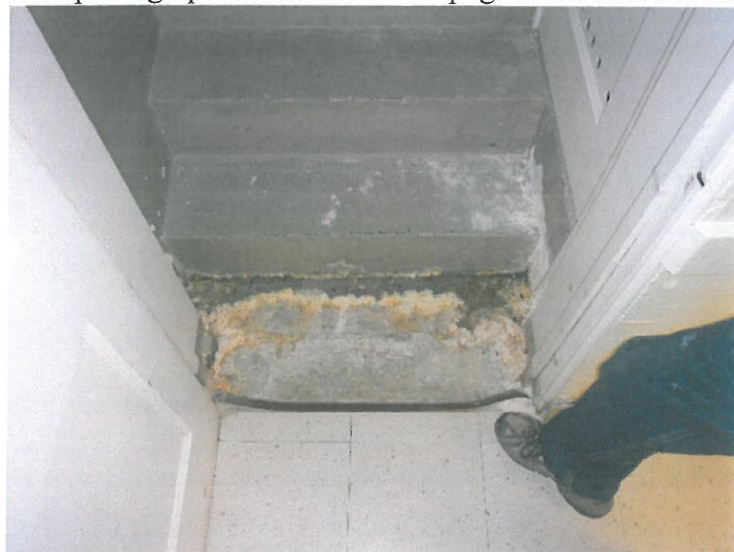
This photograph illustrates the seepage at the foot of the stairs in the lunch room area.

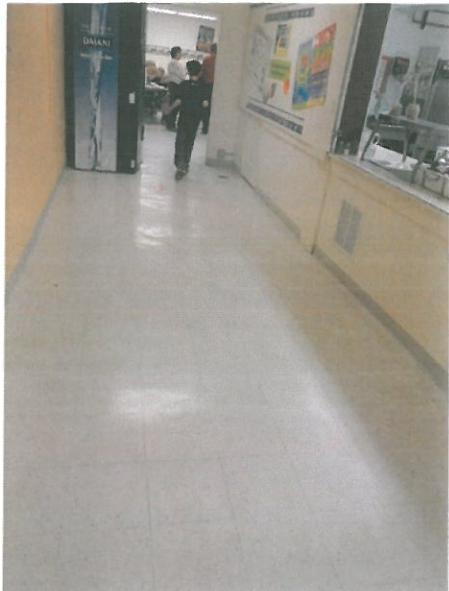
In the below photograph, there is a red mark on the floor just to the right of the vending machine. This red mark represents the point at which a waste pipe has collapsed. The waste water and material are backing up from this point.

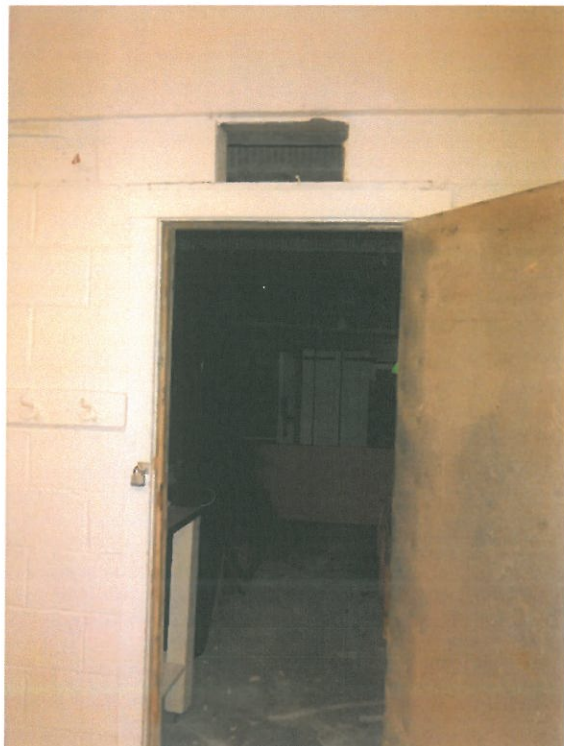
This photograph illustrates where a cinderblock has fallen out of the area above the door. This door is in the area where children and staff pick up their lunches from the cafeteria. This is in an area trafficked by both children and adults; it is immediately to the right of the entrance to the cafeteria.
